EXAMPLE - Home Performance Report

11-5-2021

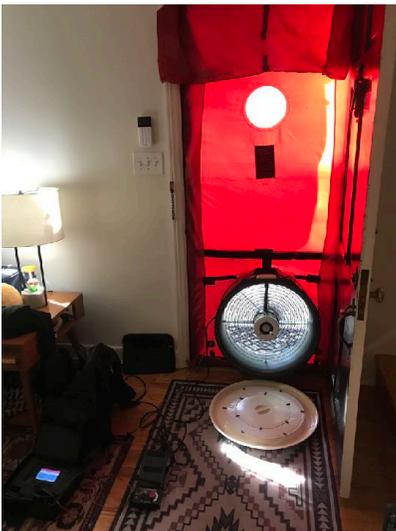
“Blower door” air leakage test result: 4,161cfm at the test pressure difference of 50Pascals (Pa). Leakage-to-floor-area ratio for the home is ~3.4. We would give the home a “F” on an A-F grading scale for air-tightness.

Improved air-tightness yields better comfort, lower energy use and improved indoor air quality (when combined with controlled ventilation). Biggest opportunities for improved air-tightness are in the crawlspace and the attic/rooflines (details follow).

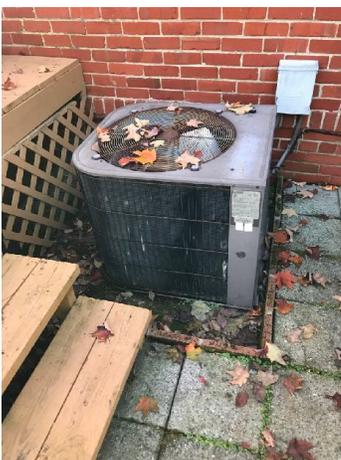
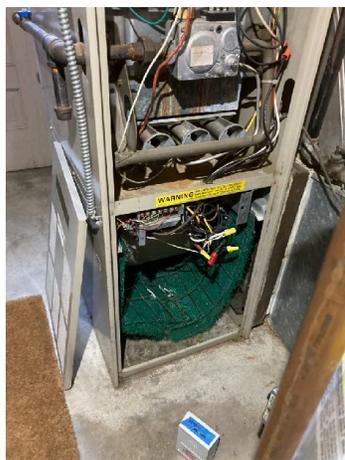
Existing heating + cooling equipment serving both floors: 60,000 Btu/hr methane gas furnace + 2.5-ton(?) AC outdoor unit from 1988...definitely ripe for replacement. Leaky ductwork is in between floors, as well as in the attic and in the crawlspace.

I did 2 iterations of heating/cooling load calculations and preliminary equipment selections: 1 for the house with existing conditions, but with new ductwork (including MERV-13 or MERV-16 filtration), and 1 for the house with sealed/insulated crawlspace + spray foam sealed/insulated roofline (minimum 30% air tightness improvement). While there’s a significant difference in heating load between the 2 iterations, there’s less of a difference in cooling load...and not enough of difference between the scenarios to justify a drop in equipment capacity. For both scenarios, I’d recommend a 1.5-ton cold climate heat pump with ~5kW supplemental heat kit (1.5-ton Mitsubishi “Hyperheat” ducted heat pump is our preferred equipment).

Neil C. will provide a quote for this work, along with a preliminary description for a new ductwork strategy that would serve just the 1st floor.

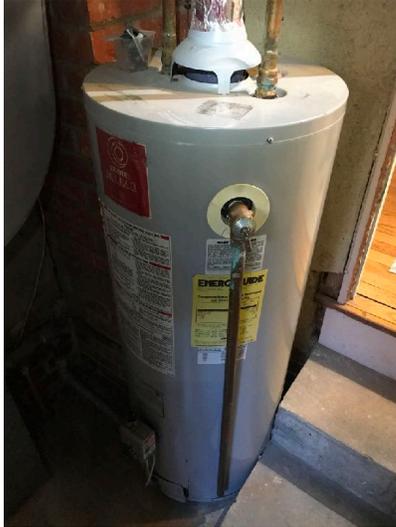
Existing water heater is a methane gas-fired 30-gallon tank from 2003 with low efficiency (0.57EF). We recommend replacing with a 50-gallon heat pump water heater (Rheem or AO Smith brand).

Replacing the water heater with an electric model (heat pump or standard) is required in order to easily + safely reconfigure new ductwork for a new heat pump.

Neil C. will provide a quote for this work.

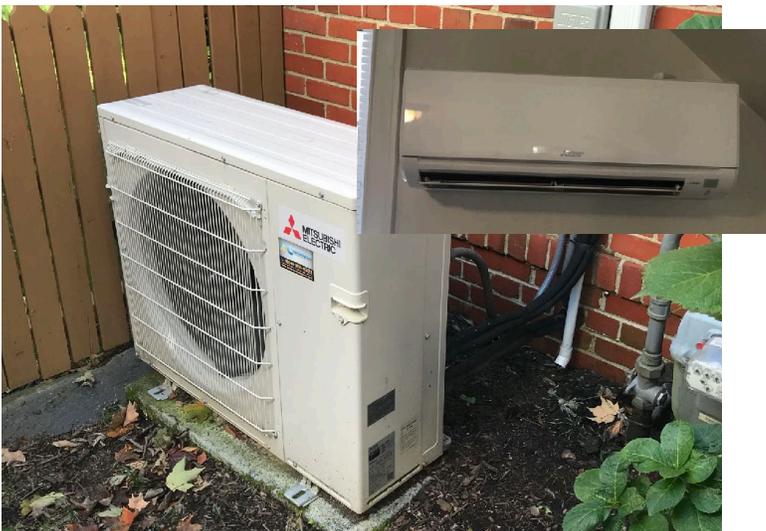
Mitsubishi 2-ton multi-split outdoor unit with a pair of 1-ton ductless wall mount indoor units (1 in each upstairs bedroom). This system currently provides supplemental heating/cooling to the 2nd floor. But with a new heat pump system serving just the 1st floor, this system would become the primary heat/cool source for the 2nd floor.

This system is rated for operation only down to 5F outdoor temperature. In very extreme cold weather, you may need to use supplemental electric resistance heaters in the upstairs bedrooms (1500W plug-in heaters cost as low as about \$50/ea).

Down the road, at time of replacement, the outdoor unit could be upgraded to a "Hyperheat" cold climate model for better performance in extreme cold temperatures.

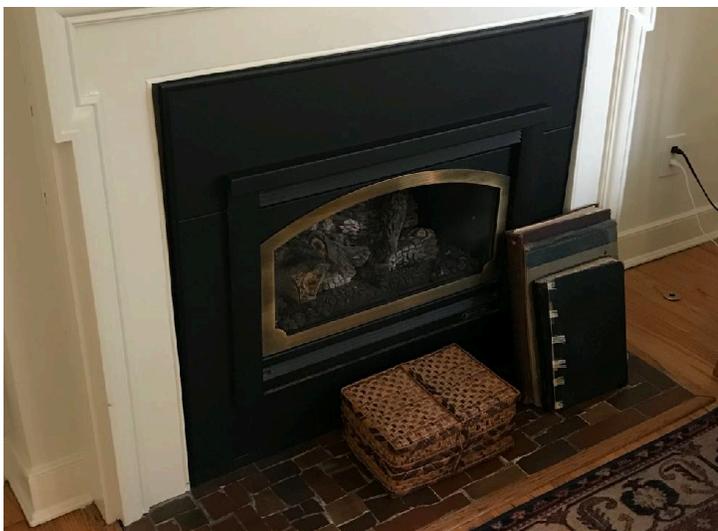
Existing fireplace use methane gas for fuel. If you electrify space heat and hot water, this would be the last remaining gas-fired appliance. If you choose to decommission this as well, then you could have your gas service shut off and save ~\$150/yr in gas meter/customer fees.

In any case, we recommend installing a "low-level" carbon monoxide (CO) monitor/alarm for improved safety if you use the fireplace in the meantime.

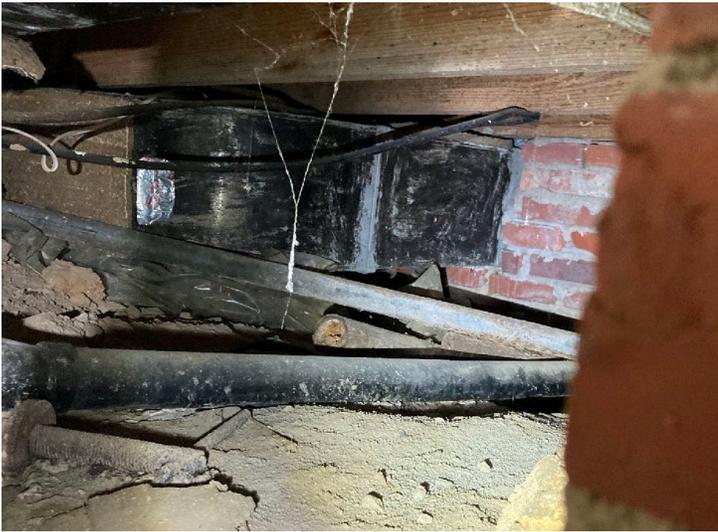
The crawlspace is low (<2-ft clearance) with no vapor barrier over the dirt, and no insulation at the foundation walls or in between floor joists. This lack of insulation, combined with the extreme air leakage are likely the biggest factors making the 1st floor uncomfortable in the winter.

We recommend creating a sealed, insulated + conditioned crawlspace (similar to modern basement construction...just shorter/smaller!).

Neil C. will provide a quote for this work.

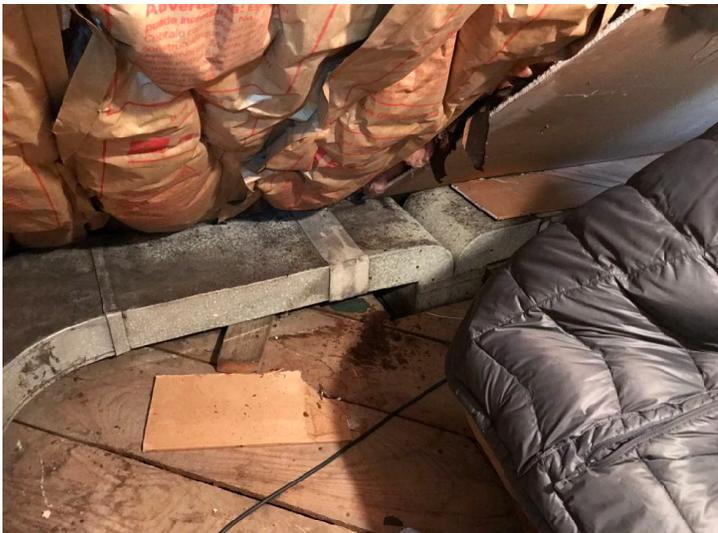
Attic spaces are insulated at the roofline with poorly installed fiberglass batts (R-19 rated insulation value). Given the air leakage measurements, it's likely there is significant air bypass of this insulation, rendering it much less effective than its printed insulation rating.

We recommend removing the existing insulation and using spray foam at the roofline (approximately R-30) to address the air leakage issues in the attic/roofline areas, and to re-insulate.

We don't do spray foam work directly, but if desired, Neil can provide "owner's rep" services to you for \$125/hr to bring in a spray foam insulation contractor/s to provide quotes, provide oversight of their work, and conduct follow-up blower door air-tightness testing to confirm air-tightness goals are met.

Proper installation of spray would involve some cutting/patching of the flat ceiling in order to access the roof peak, as well as the sloped ceiling in any inaccessible areas (possibly over the stairway, for example).

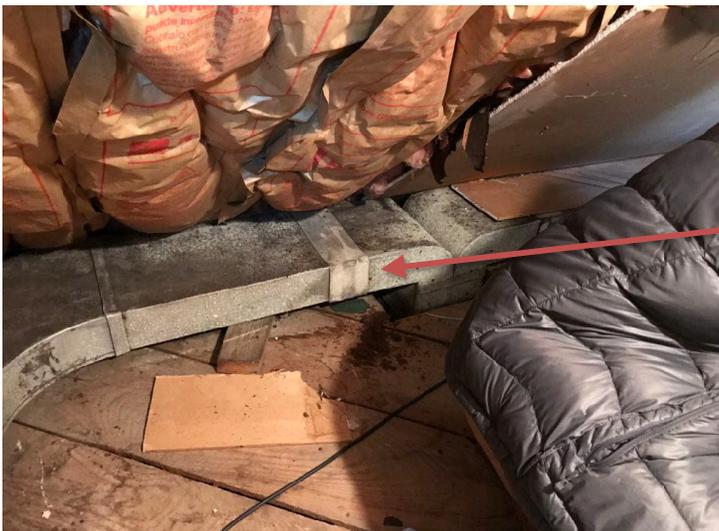
We suspect the tape that was used to seal some of the joints in the attic ductwork may contain asbestos.

There may also be some hidden ductwork in between floors with the same tape.

If removal of the attic ductwork is part of the overall plan, then the tape would probably need to be tested...and if it contains asbestos, removed by a certified specialist before we could proceed with further ductwork removal.

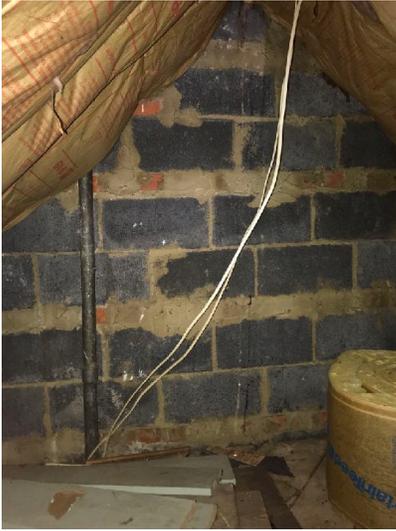
Attic gable ends as well as the mechanical room on the 1st floor are uninsulated. The gable ends can be insulated as part of a spray foam package.

As for the mechanical room, Neil can probably offer an insulation + air-sealing option that could go in conjunction with heat pump + water heater work in that room.

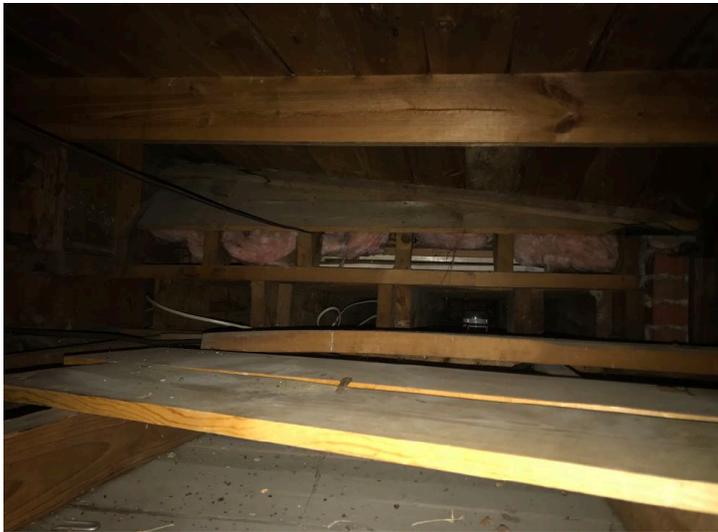
View from the enclosed porch attic toward the floor joists over the kitchen. There is no air barrier or insulation separating the kitchen ceiling from the unconditioned porch attic.

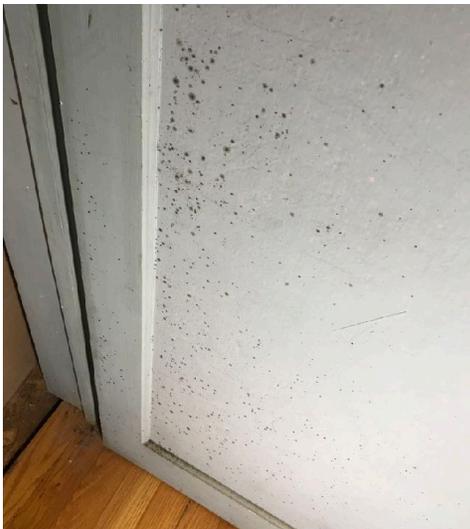
At least a couple of attic knee wall doors showed signs of mold growth on the backs of the doors. This is likely happening in the summer...due to the very high air leakage rate, hot, humid air from outside can migrate into the attics, with moisture accumulating on the cool surfaces that are adjacent to the air-conditioned rooms.

With enough moisture accumulation, mold growth can occur.

Neil can offer a clean-up option for these doors - remove mold with wire brush + HEPA vacuum...optional repaint?

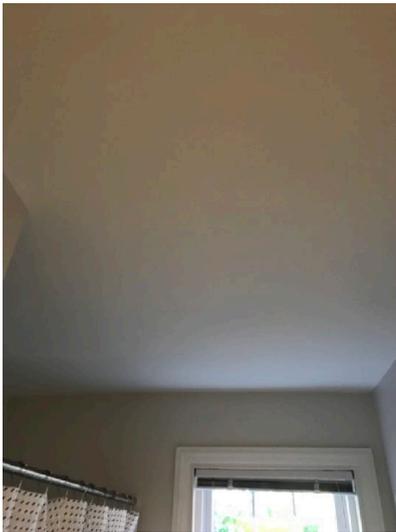
The 1st floor bath fan does not currently have an exhaust fan. Neil can quote adding a quiet and effective exhaust fan to this room if desired.

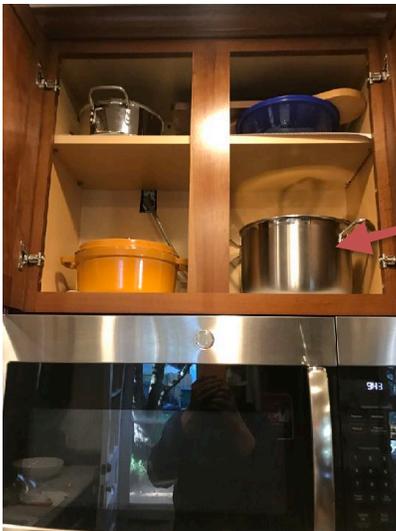
The kitchen microwave range hood recirculates air to the kitchen, rather than exhausting to the outdoors.

Although electric cooking is less polluting than gas cooking, best practice is to vent the range hood to the outdoors and to use it every time you cook in order to remove fine particulates and other pollutants generated by cooking.

We didn't look at potential duct routing for a retrofit duct to the outdoors, but can do so at a follow-up visit, if desired.

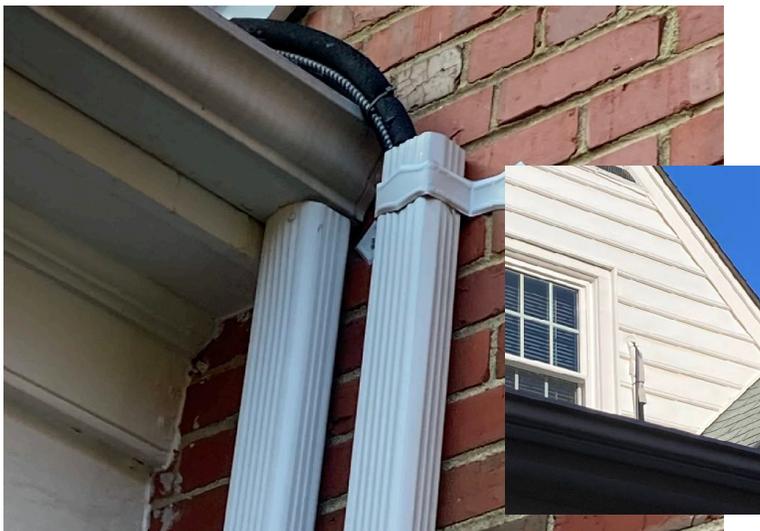
The insulated refrigerant pipes that run from the E/SE 2nd floor bedroom to the Mitsubishi multi-split outdoor unit have several sections that are unprotected from UV radiation (from sunlight). The insulation is starting to degrade (easiest to see in person from the bedroom window, looking down to the enclosed porch roof).

We recommend replacing the degraded sections of insulation, and installing a protective covering (PVC "lineset hide" ...looks similar to a downspout gutter, is typical).

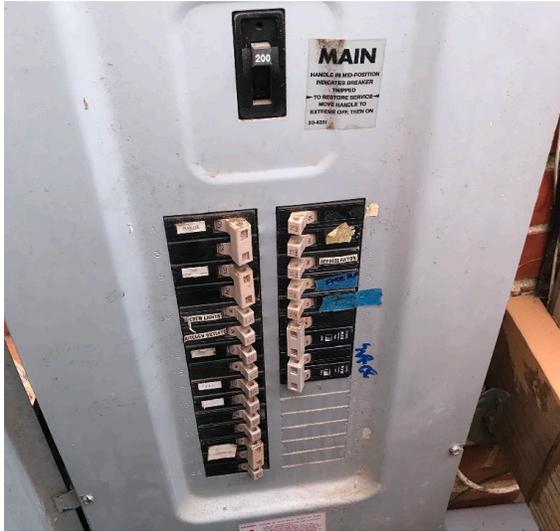
Existing electrical panel is outdoors, with 200A main breaker and several open circuit slots.

Should be no problem in terms of heating/cooling + hot water electrification...with plenty of room/capacity leftover for future electric vehicle charging infrastructure and/or whole-house battery backup.
